Macrophyte removal in LAKE KEMNADE, GERMANY

Background

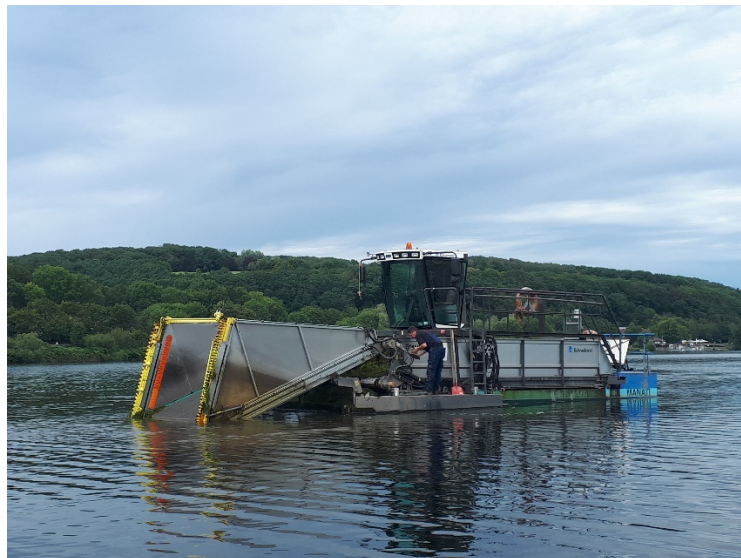
Fig. 3: Mowing boat at Lake Kemnade in July 2020

The mowing boat at Lake Kemnade could not remove all *E. nuttallii* biomass, since the boat is designed to leave the 50 cm of vegetation immediately above the sediment to prevent damage to the cutting mechanism from rocks and other objects. As a result, the macrophyte cover remained around 100% in the control and impact site, before and after mowing, with plant height being significantly reduced in the impact site (from 120 to 60 cm). As a result, the PVI (plant volume inhabited) was reduced by over 60% in the impact site (Fig. 6A). At the control site, both PVI and biomass remained constant during the experimental period. In the impact site, mowing removed 310 g of plant dry weight m⁻² (Fig. 6B).

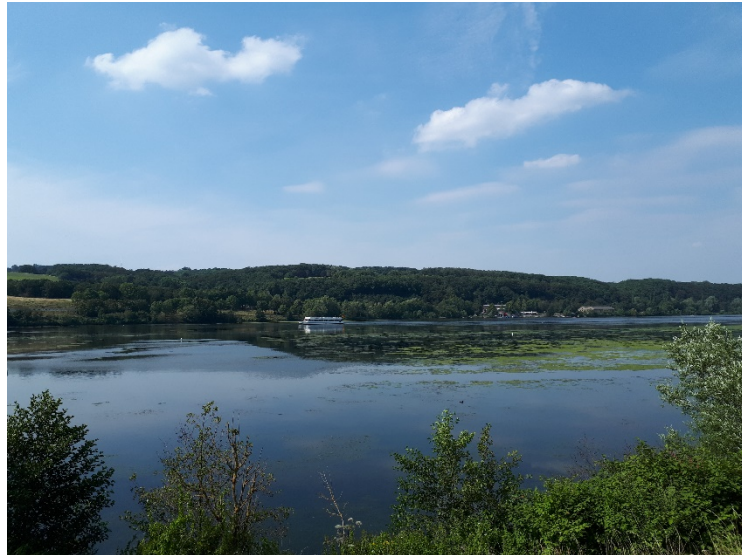
Fig. 4: Mowed (left) and unmowed (right) control sites at Lake Kemnade in July 2020

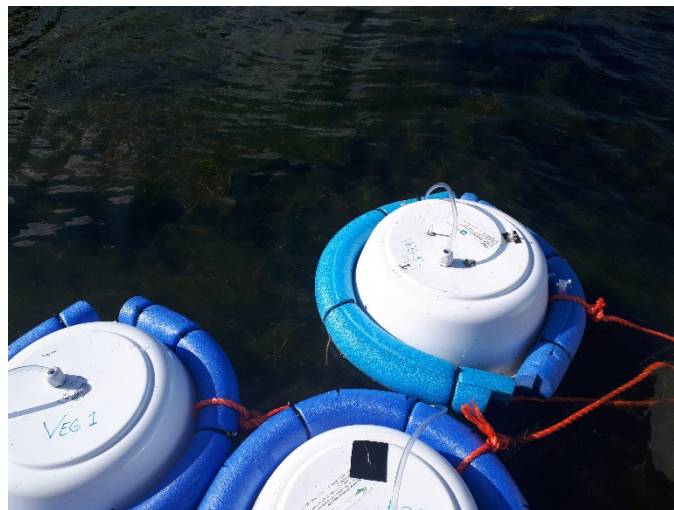
Fig. 5: Floating chambers to measure greenhouse gas emissions in Lake Kemnade in July 2020

In summer 2020, two sections (each 50 x 100 m) of the lake were allocated for the MadMacs project. Surveys of the vegetation cover, PVI (plant volume inhabited, that is the percentage of the water column that is “filled” with macrophytes) and biomass were carried out before and after the removal of *E. nuttallii* from the impact site. The other site was left vegetated as a control (Fig. 4). In addition to vegetation data, we collected information on the water quality, greenhouse gas emission (Fig. 5), biodiversity and hydrology.

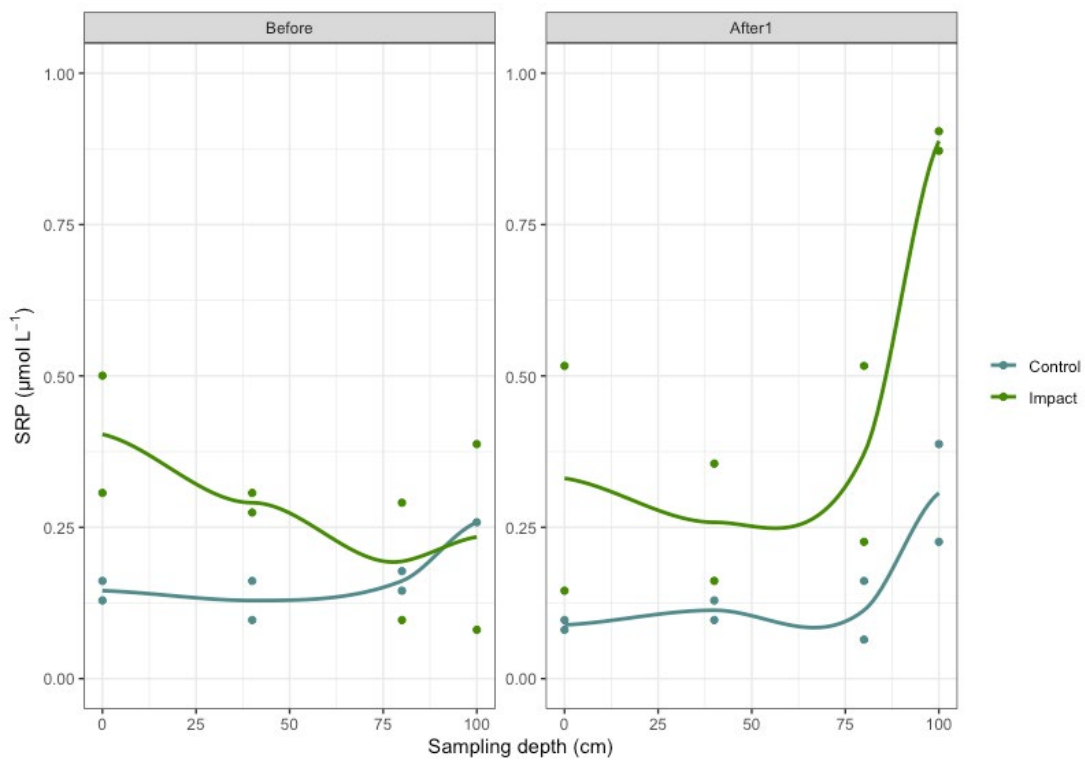
Fig. 8. Phosphorus (measured as Soluble reactive phosphorus (SRP)) concentrations, determined before and after mowing in the control and impact site at Lake Kemnade.

With depth, there were more suspended particles in the water in both the control and impact site (Fig. 7), but no differences were found between the control and impact sites. Although phosphorus was already higher in the impact site before plant removal, the concentration increased strongly after mowing in the impact but not in the control site (Fig. 8). In the lake, nitrogen was predominantly available as nitrate (NO_3^- ; $91 \pm 4.5\%$; Fig 10), while the availability of ammonium (NH_4^+) increased with depth ($P=0.013$; Fig. 9). Furthermore, the concentration of NH_4^+ briefly increased in the impact site compared to control after mowing.

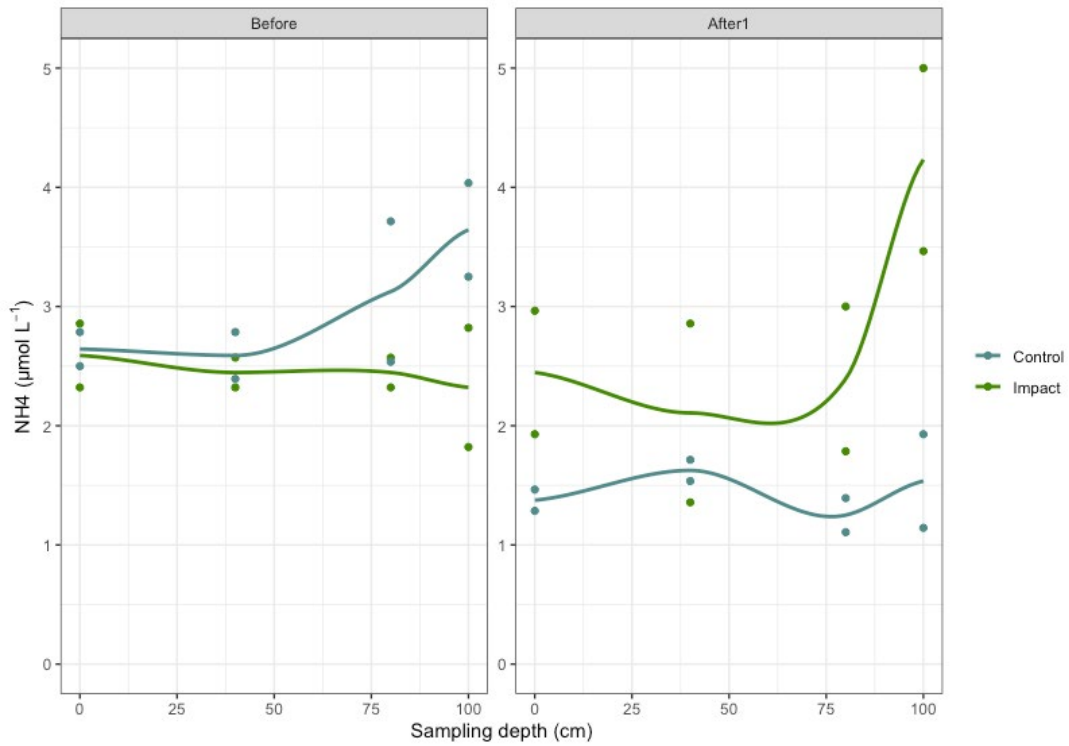
Fig. 9. Ammonium (NH_4^+) concentrations, determined before and after mowing in the control and impact site at Lake Kemnade.

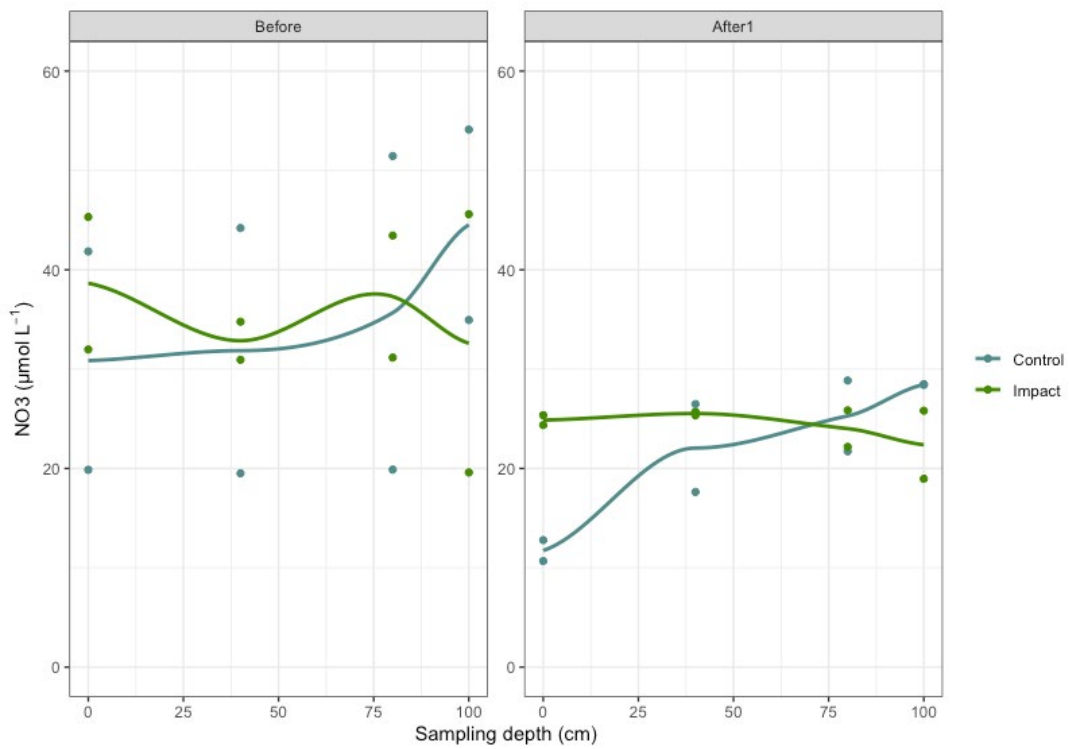
Fig. 10. Nitrate (NO_3^-) concentrations, determined before and after mowing in the control and impact site at Lake Kemnade.
